# The Hydraulic System of Banteay Chhmar

Technical Report · January 2011

**Damian Evans, Archaeologist, University of Sydney  
James Goodman, Consultant, Global Heritage Fund  
John Sanday, GHF, Director, Banteay Chhmar Conservation and Training Project  
Mey Ra, Archaeologist, GHF**

**January 2011**

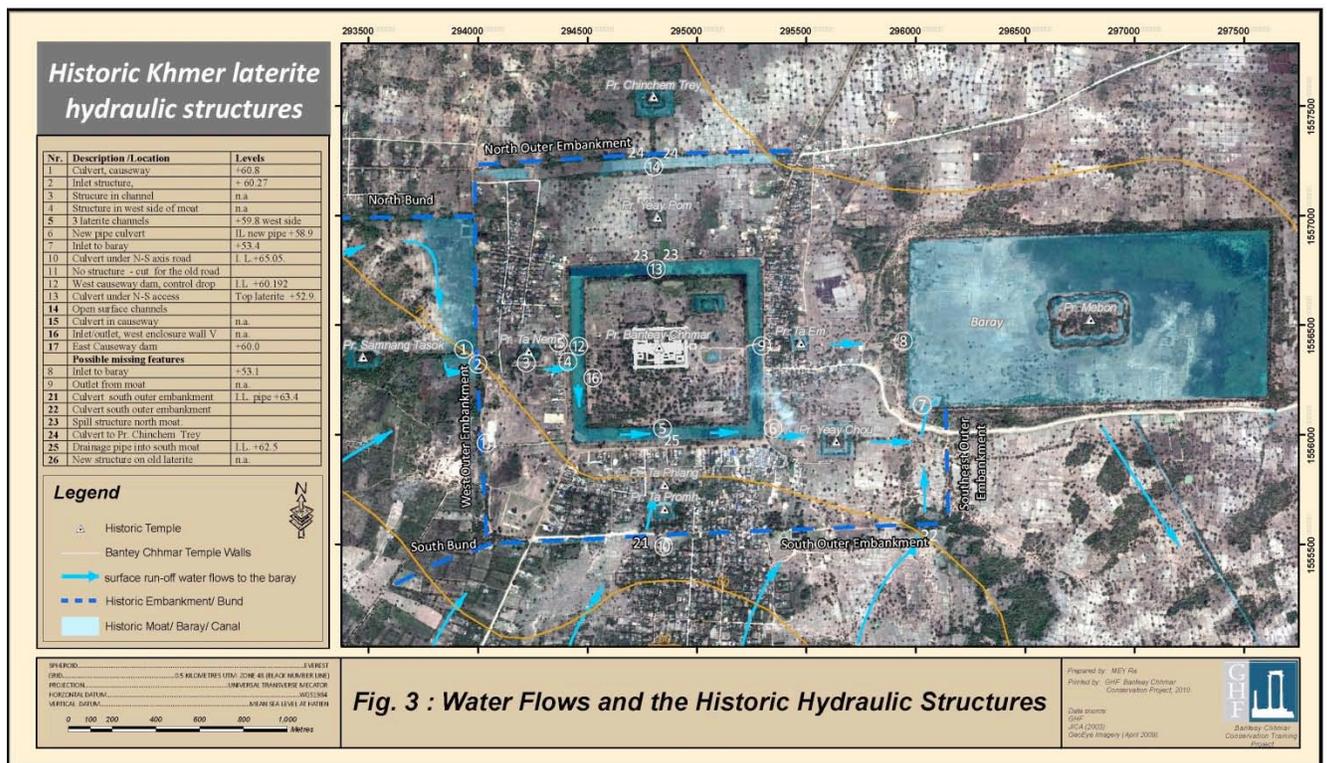
**Fig. 3 – showing location of ancient hydraulic structures at Banteay Chhmar**  
**3. Historic Khmer laterite hydraulic structures**  
 (Table 1 below should be read in conjunction with Fig. 3 above and the Water Flow Schematic)

Most of the structures that comprise the hydraulic system at Banteay Chhmar still function as designed after 800 years. The invert, or bottom levels, of these structures and lined canals are measured to datum and the system design is revealed

<b>No..</b>	<b>Description /Location</b>	<b>Levels</b>	<b>Remarks</b>
1	Culvert type structure in causeway to West satellite temple Pr Samang Tasok. 2-3 openings, 3m wide channel	Invert level <+60.8	Excavation required
2	Inlet structure, West outer embankment; 3 arched laterite lined channels 1.5 m high openings, 3 m wide channel leading to No. 3, below	Invert level +60.27 Full records and drawings held at GHF office	Excavation February 2010; temporary repairs to structure. To be fully conserved when funds available
3	Structure in channel from No. 2 above immediately adjacent to the South embankment of Pr Ta Nem – one channel Eastwards to No. 4, below	To be levelled after excavation	Excavation required
4	Structure in West side of moat about 100metres South of the West causeway taking water from No. 2 via No. 3 into the South (higher) section of the West moat. Possible discharge location of original drainage channel from No.. 2 above	To be levelled after excavation. Water level in SW moat, March 2009, of +59	Excavation required

5	South causeway – 3 laterite channels (0.75 deep, 0.45 wide) within the causeway structure: function to channel water from SW moat to SE moat	+59.8 West side	To be conserved and re-commissioned during the conservation of South causeway
6	No extant historic structure: a new pipe culvert replaced a bridge when the road was constructed around the temple (1962?). This was the overflow from the SouthEast moat which led surplus water, via a laterite lined channel, to the moat system of Pr. Yeay Chou, and thence to the <i>baray</i> at No. 7	Invert level of new pipe culvert +58.9	
7	Inlet through SouthWest bund of <i>baray</i> : a long bed platform of laterite blocks	+53.4 measured at the road crossing just in from toe	Presentation only
10	Culvert under N-S axis road, just outside South outer embankment (North of Pr. Ta Prohm)	Invert level+65.05. Compare this level with invert level of No. 21, +63.4	Excavated completed in March 2010.

11	No structure but a cut in the West outer embankment made by the old road to Thmar Puok. Converted by the French into the main channel of runoff into the SouthWest corner of the moat system via a new culvert under road		Not part of the old Angkorean water system but crucial in modern times: the route of the runoff from the West catchment
12	West causeway: a dam on the West side separating the split level moats with a control drop structure in the centre – water can discharge from SW to NW moat in emergency	I.L spillway +60.192 Water levels, March 2009: SW moat +59.0 NW moat +57.0	Detailed investigation required. Are the laterite slopes leading up from the axis as measured deliberate slopes or settlement?
13	North outer embankment and moat – culvert under raised access platform into the moat complex	Top of laterite structure +52.9. Invert level once excavated	Excavation required
14	North causeway – open surface channels on the causeway: function to channel water from NW to NE or vice versa? (note that there is only a drop structure on West causeway, no drop structure on East causeway)		Presentation only

15	N-S structure on E-W axis access to Pr. Ta Nem	To be levelled after excavation	
16	Hydraulic feature running through Southern section of West enclosure wall with lined channel	To be levelled after excavation; levels of inner ponds to be compared	
17	The East Causeway: a dam which separates the Eastern arm of the higher Southern quadrant of the moats from the Northern quadrant. The main access to the temple. There is no evidence of a control structure in the causeway		
	<b>Possible missing features</b>		
8	Inlet through West bund of <i>baray</i> , immediately on the North side of the temple on E-W axis: discharge from Pr. Ta Em moats	+53.1 water level in <i>baray</i> , March 2009, +51.2	Excavation required
9	Outlet from immediately South of East causeway perhaps feeding Pr. Ta Em ponds and discharging into	To be levelled if confirmed and excavated	Channel under road to be confirmed, or otherwise by GPR. If

<i>baray</i> at No. 8, above		positive, excavation
<b>21</b>	Culvert through South outer embankment, just East of Pr. Ta Prohm draining some of the runoff from the South and diverting some water to Ta Prohm moats. New 3 pipe culvert system here leading in a dog-leg alignment to the culvert under the road by the South causeway – in the original location possibly	Invert level of new pipe culvert +63.4	
<b>22</b>	East end of South outer embankment – culvert to take water from outer moat on South side of South outer embankment, through outer embankment and into the <i>baray</i> at No. 7. A new culvert some 50 metres West of corner		50m metres to the West of this structure there is a new culvert constructed over an ancient culvert; the invert level is not recorded but it is much higher on the South embankment. Currently this pipe is blocked and water from the Eastern portion of the South catchment flows through a cut in the embankment some 1-200 m West of No. 22

<b>23</b>	Only a new culvert providing spill capacity to the North moat.		GPR investigation either side of the North causeway alignment
<b>24</b>	Probably a culvert from the North outer moat to the outer satellite temple Pr. Chincham, Trey, running beside the causeway on the N-S axis		
<b>25</b>	Drainage from the South of the moat system and drainage from the South catchment through structure No. 21, enters the Eastern section of the South moat. It is now replaced with a formal 2 pipe culvert	Top of culvert +62.5 Invert level of new pipe culvert +60.5	
<b>26</b>	A modern pipe culvert constructed on an old laterite base, 50m West of structure No. 22, across South	1.5 m higher than structure No. 22

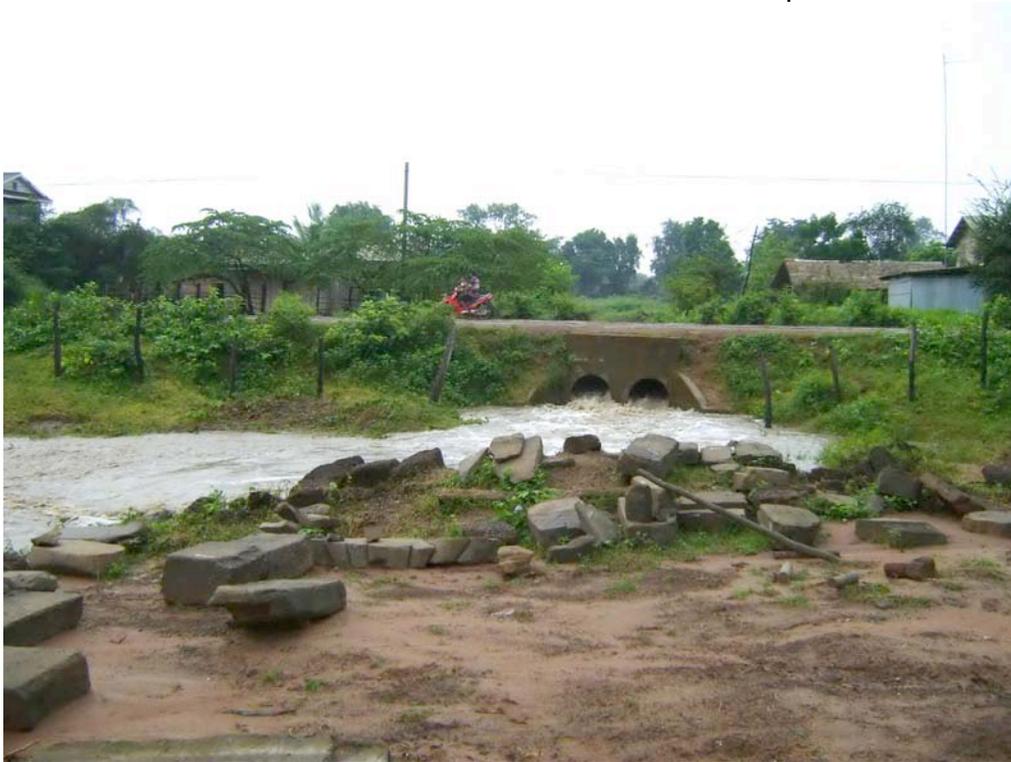
The location of this new culvert, No. 25, under the road to the market bringing the run-off from the Western portion of the South catchment should be re-located a few metres to the East so that it is not on the alignment of the South causeway; apart from the presentational aspects the scouring of the South causeway is noticeable

A well forested canopy over a small catchment (the area of the South and West catchments is approximately 1,500ha) will have controlled run-off and ensured good groundwater re-charge; run-off flows and groundwater flows will be steady and constant rather than the violent run-off of the now heavily deforested catchments in the 2008 and 2009 floods. The 2009 Ketsana storm resulted in high run-off as shown in the photograph taken of the 2 barrelled 1metre diameter culvert some hours after the peak storm had

#### **Ketsana floods 10/2009: flow through new culvert by South causeway: looking South from the South Causeway itself**

The increased run-off due to deforestation requires changes to the modern culverts to accommodate this increase if flooding and overtopping of the causeways is to be prevented. In particular, the SE corner culvert by the market will be significantly increased in capacity to accommodate flows such as those experienced during Ketsana storm.

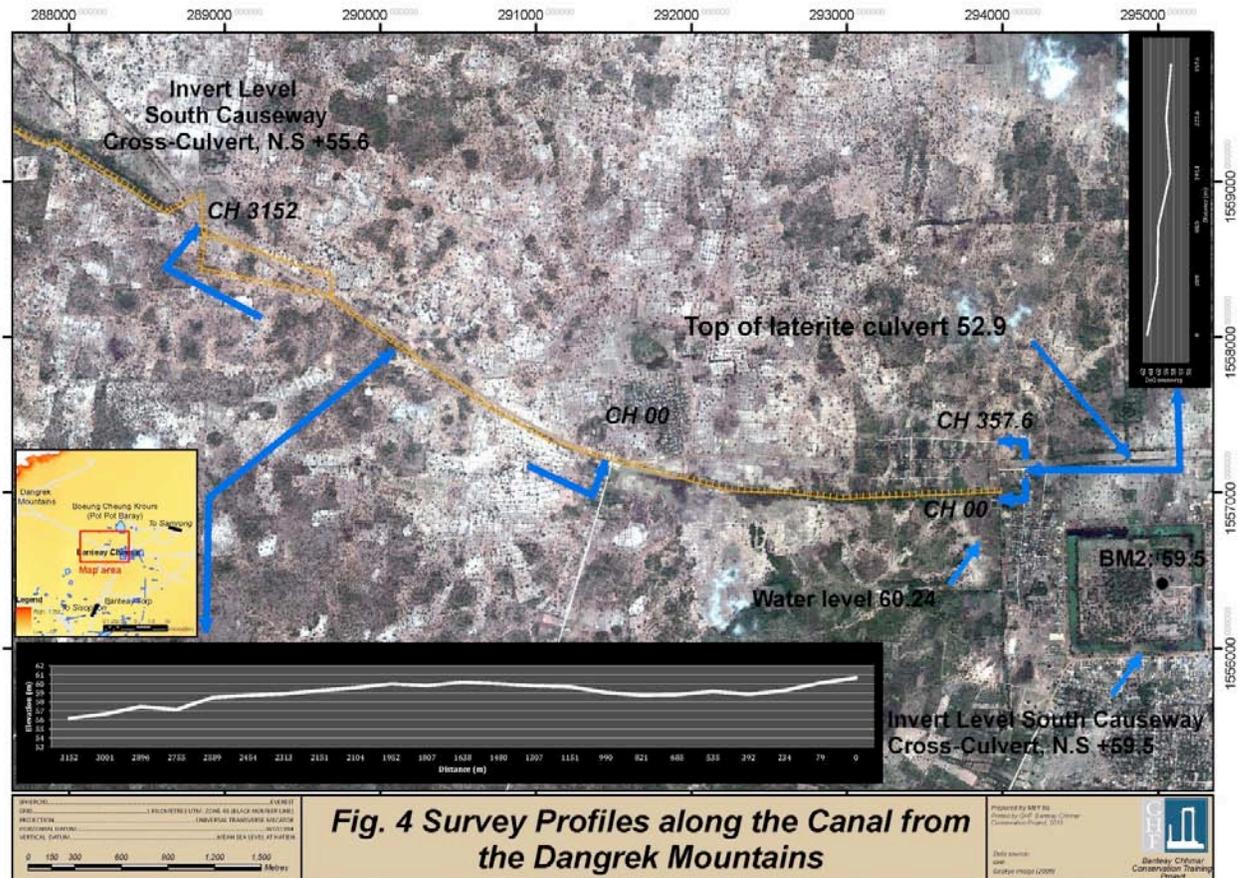
**Fig. 4 : Survey runs and profiles on the Dangrek Canal and N-S along the West end of the North Moat**

The first survey was run along the road from the Northwest corner of the West outer embankment system of Banteay Chhmar through Kbal Tonsong (the village in the centre of the plan from where a road runs straight down in direction SSW, CH 00 in **Fig. 4** above) and to the end of the canal with raised banks in the Northwest. The road profile is plotted from Kbal Tonsong to the East end of the aqueduct section of the canal (the elevation profile is presented in the bottom left hand corner of **Fig. 4**).

End of the Dangrek invert canal level: + 55.6, invert level of structure No. 1 through the causeway to the West outer satellite temple +60.8, invert level of structure No. 2 through the West outer embankment + 60.2. The survey shows that it is improbable, due to the very height of banks required, that there was an aqueduct, to take water from the Dangrek into the moat system and into the *baray*.

It should be noted here that theoretically, with some judicious excavation, the survey levels allow water to flow from the end of the aqueduct into the North inner moat (the moat just North of the temple complex) and indeed onward to storage in the *baray*; alternatively the levels would allow the water to have been channelled to the North outer moat (the moat just inside the North outer embankment). The earthworks would have to have been substantial; there is no evidence either in the satellite imagery, the 1945 air photographs or from on-the-ground investigations (including extensive interviews with the market gardeners along the North West moat of the complex) of such a canal or structures at the Northern section of the West outer moat (obscured by recent road construction), from the West outer bund to and into the NW section of the North inner moat or from the NE section of the Northern moat system to the *baray*.

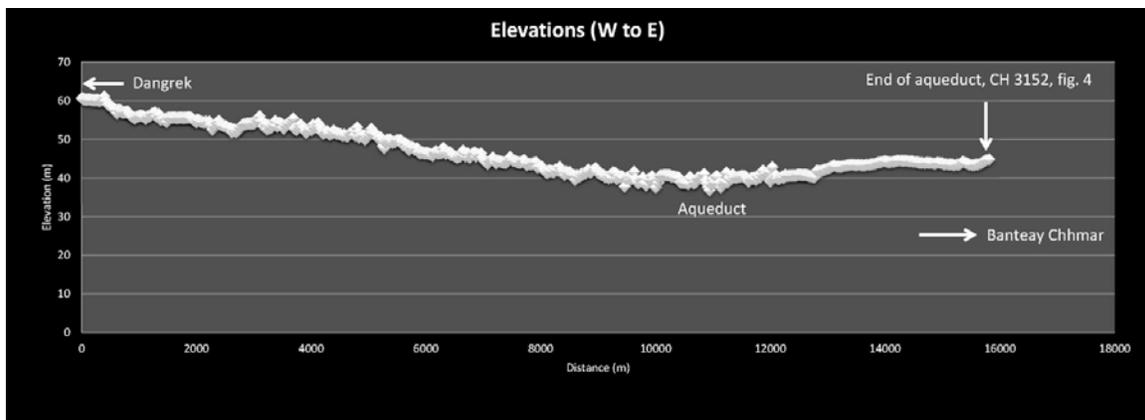
Fig. 5 GPS Survey Profiles along the Dangrek Canal

The survey showed that there would have had to have been a 4-5 metre high aqueduct at the end of the visible portion of the aqueduct/canal from the Dangrek. Prior to the survey, the perception and understanding of the topography in this area was that the banks of the aqueduct/canal may have been the remains of a massive aqueduct and that the aqueduct flowed downwards from the diversion at the watercourse to this low point at the the end of the visible portion of the aqueduct/canal. A GPS survey tied to the benchmark at the end of the aqueduct/canal (and carried from the site benchmark by NE corner of the temple) showed that this may not be the case.
