DID TRADITIONAL CULTURES LIVE IN HARMONY WITH NATURE? LESSONS FROM ANGKOR, CAMBODIA

Terry Lustig¹, Roland Fletcher², Matti Kummu³, Christophe Pottier⁴ & Dan Penny¹

1 Introduction

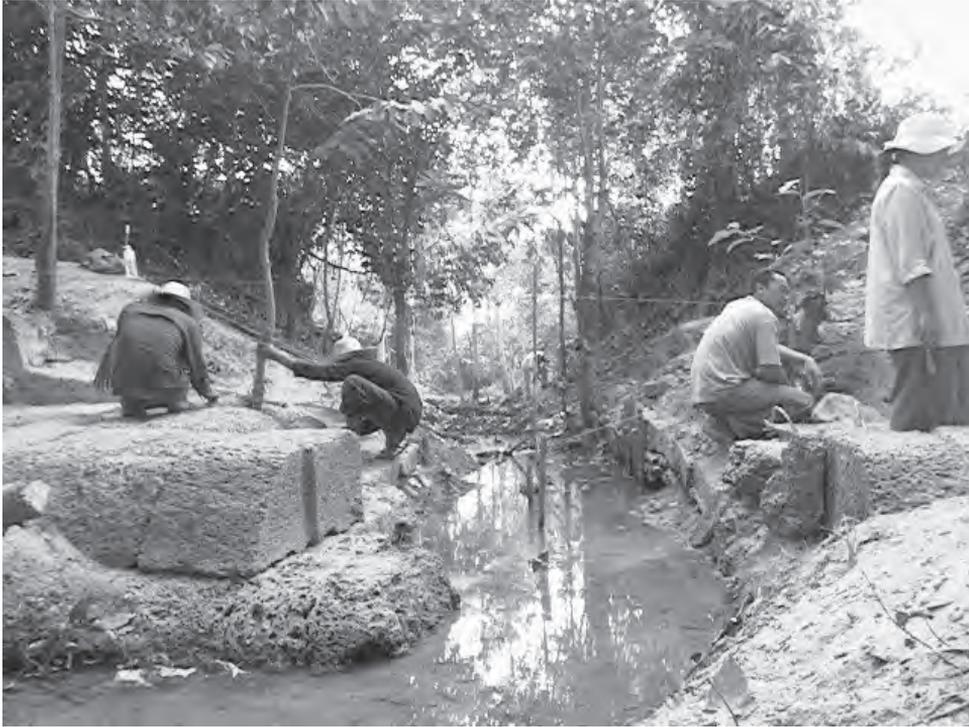
Figure 6 Spillway and Bam Penh Reach channel. Excavation nearby indicates base of spillway is about 1½ m below the crest.

The western edge of this platform has the form of a spillway about 1½ m high (Figure 6), and was apparently designed to pass large volumes of water, consistent with what may have been all or part of the Puok River in flood. If the off-take to the Siem Reap River was built at the same time

as this platform, this may mean that water was flowing in three directions: to the west along its original channel, along an offtake from the Puok at the start of the Siem Reap channel, and over the spillway, again to the west, to skim off excess flow in the Siem Reap channel in times of peak floods. To confirm this however, needs further study.

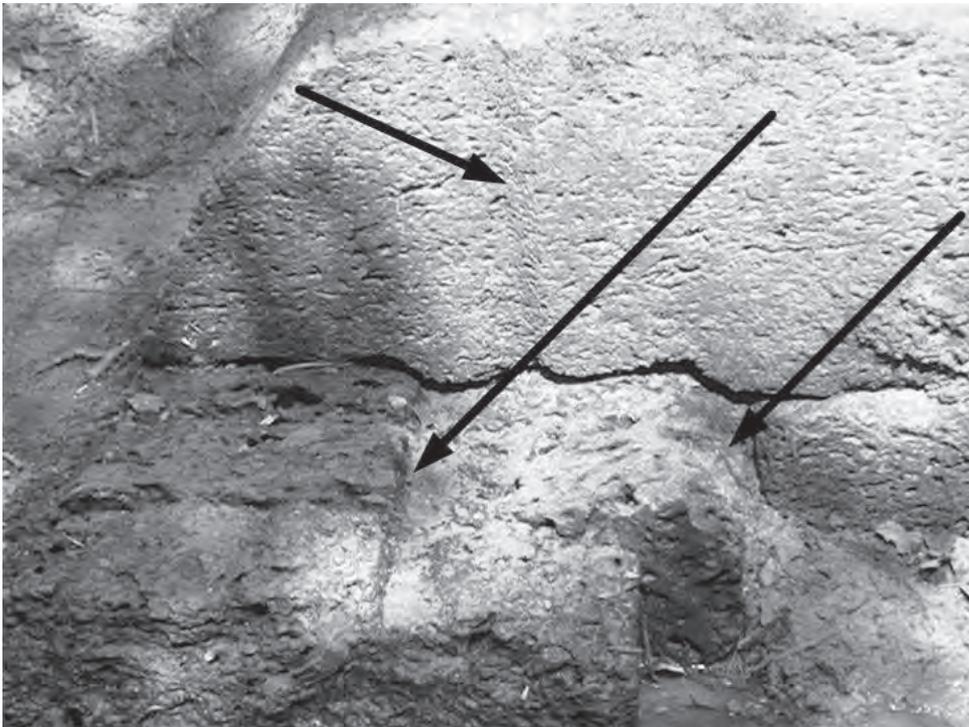
Figure 7 Vertical and horizontal keys in spillway construction.

An interesting feature of the spillway is that its laterite blocks are assembled with vertical and horizontal keys, seemingly designed to resist the forces of water flowing westwards (Figure 7). This mode of keying is a common feature of the temples of Yasovarman I (Boisselier, 1966, p. 112), which supports Groslier's (1979, p. 173) contention that the Siem Reap's off-take from the Puok was to provide water for the East Baray, built by Yasovarman or Rajendravarman (Groslier, 1958, p.110, n.2; Groslier, 1979, p.176; Pottier, 1999, p.101, n.294). This suggests that the Siem Reap
